UNIVERSITY OF WINDSOR
ELECTRICAL ENGINEERING CO-OP

IMPROVING BRAKES FIRST TIME CAPABILITY

FIAT CHRYSLER AUTOMOBILES
RESIDENT ENGINEERING
WINDSOR, ON

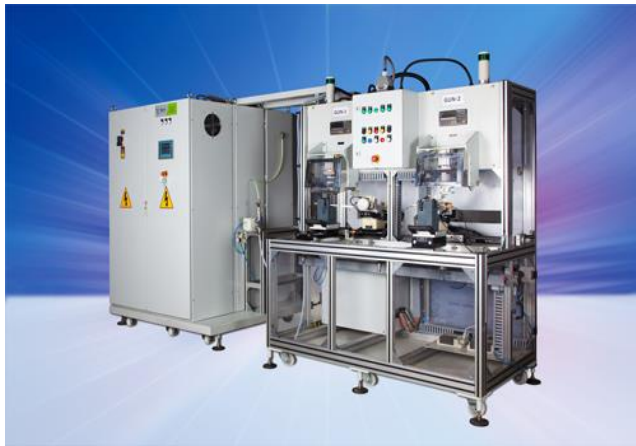
Figure 1: A Typical Brake EVAC machine

Once a vehicle's brake lines, brake pedal, master cylinder, Antilock Braking System (ABS) pump, and front/rear brakes have been installed, the resulting hydraulic circuit must then be filled with brake fluid. Since air is much more compressible than brake fluid, it is very important that very little air is left in the circuit once the vehicle is filled with brake fluid or else the brake pedal feel (how far the pedal must be depressed in order to attain the required value of brake caliper piston force) will be inconsistent which can lead to fatal consequences for the customer. In order to ensure only insignificantly small quantities of air enter the braking system, vehicle manufacturers use a device called a Brake Evacuation and Fill machine (Brake EVAC machine). A picture of a typical Brake EVAC machine and the adapter used to connect the machine to the vehicle are shown in figure 1 and figure 2, respectively.

The overall goal of the Brake EVAC machine is to adequately fill the brakes system of a vehicle quickly enough for mass production while ensuring very little air is allowed in to the system. In order to do so, there are several phases to a Brake EVAC cycle. These phases consist of:

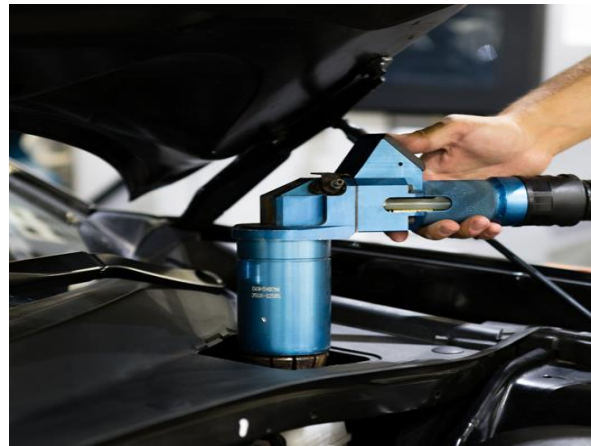
Figure 2: A Typical Brake EVAC machine Adapter

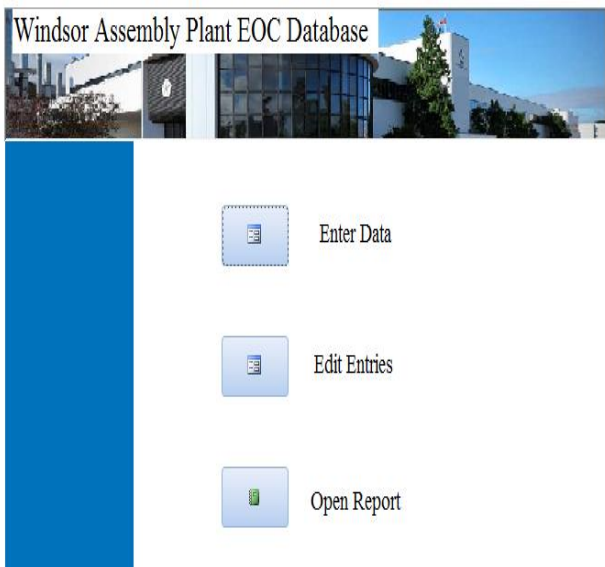
Figure 4: WAP EOC Database User Interface

entire day. This is obviously not possible since the engineer has much more to do than stand around and wait for a failure. However, there are people in station at all times: the operators. By sharing information with the station operators, many issues can be tracked much more closely. This method of investigating in station and discussing issues with online operators is known as the 3G/5G method. By notifying operators of potential issues and causes, they are much more likely to watch for the issue and keep track of it. However, even in doing so, it is very hard to attain a true count of occurrences as input from the operators cannot be directly used to drive change because it doesn't provide enough real evidence. Thus, in order to create a trackable link between operators and management, an entirely new database was implemented and used by the operators in the Brake EVAC and pedal pusher stations. In doing so, it provided management with profound evidence that could be used to expose and track various vehicle and machine issues that would have gone otherwise unnoticed. The new database, which can be seen below (figures 4 and 5), was named the "End of Chassis Database" (EOC Database) because of its location in the plant, and it introduced real time data directly from the source as to why vehicles were failing the brake EVAC and pedal pusher machines.

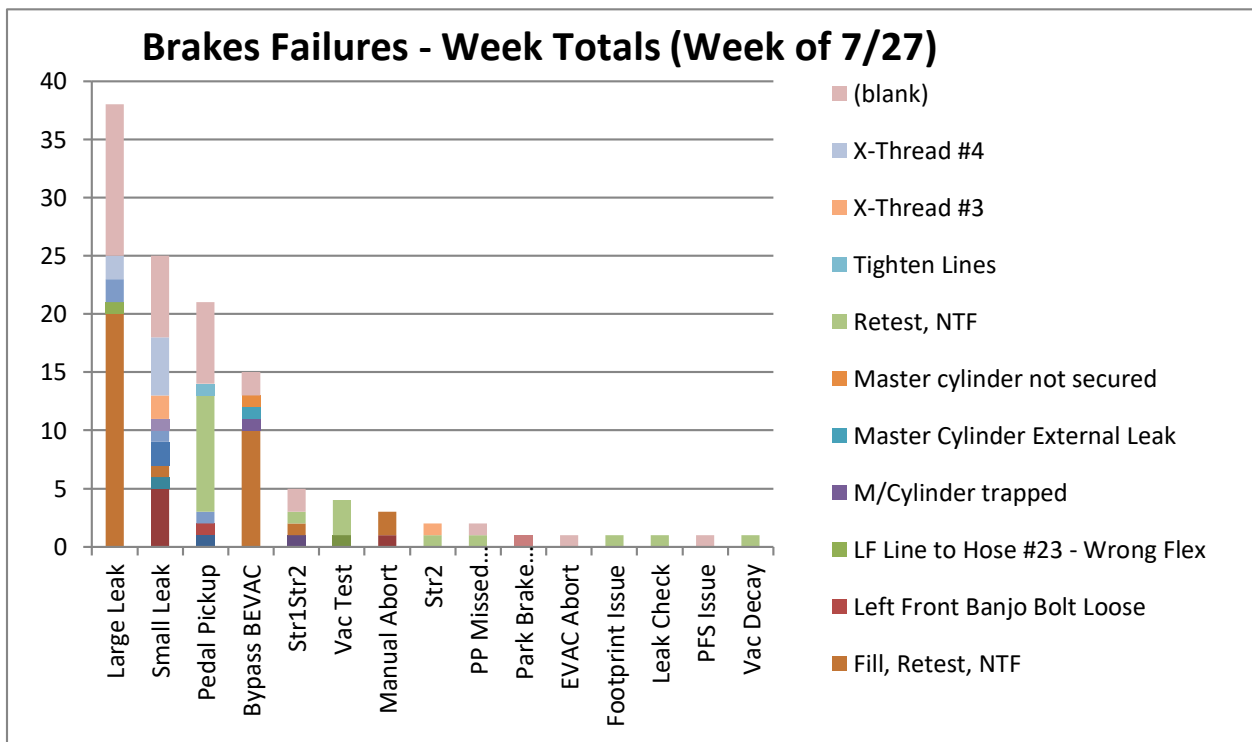
Figure 6: A Graph Showing Total Failures by Failure Mode and Repair. Author: Eric Parker

By applying the data stratification techniques described earlier, the brakes team was able to identify top machine failures and how they were being repaired. By resolving the most frequent issues first, the team could save the greatest number of cars from having to be repaired which enable the company to save the most money. As seen in the graph below (figure 6), the machine failure data indicated that the most brake failures were “Large Leak” failures. “Large Leak” failures are vehicles that failed the Primary Vacuum Test phase of the brake EVAC test cycle. As previously stated, vehicles fail this test phase when a vacuum cannot be created within the brake line circuit. This usually indicates the presence of a hole within the brake lines where there is air leaking into the system. However, as seen in the figure 6, most of these vehicles were found to contain no defects whatsoever (the repair performed was Fill, Retest, No Trouble Found [NTF]).

In other words, the machines were indicating the presence of a leak within the vehicles but the repair data stated there was no trouble with the cars. Since the machines were operating correctly and the vehicles were non-defective, it meant the air leak must have been coming from between the vehicle's brake fluid bottle and the Brake EVAC machine's adapter which mounts to the bottle. This issue could have been caused by two things: operators incorrectly seating the Brake EVAC adapter to the vehicle or a bad seal created by the Brake EVAC machine adapter.

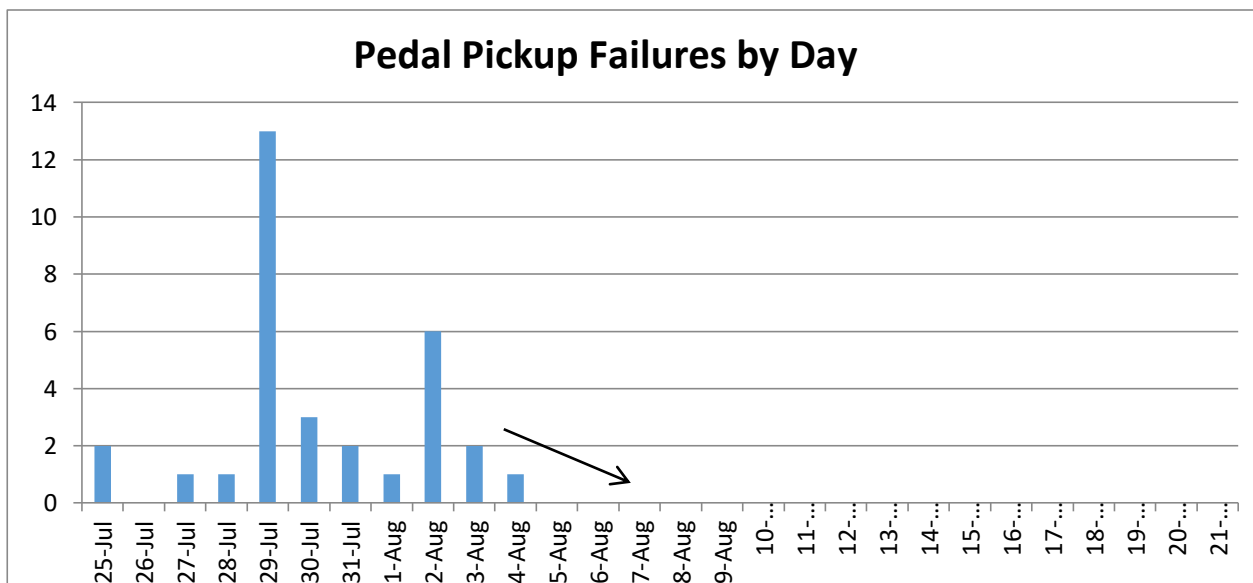
Figure 10: Pedal Pickup Failures by Day. Author: Eric Parker

Clearly, the updated fixture worked well on pedal pusher number three (since figure 9 contains zero style 5 failures). Therefore, to solve the issue on pedal pushers number one and number two, the same solution was transferred over. Both pedal pusher number one and pedal pusher number two received the updated fixture on Wednesday, August 5th. As indicated in figure 10, the issue was no longer present following this change.
